# ES\_LPC43S50/S30/S20

Errata sheet LPC43S50, LPC43S30, LPC43S20

Rev. 1.6 — 20 April 2016

Errata sheet

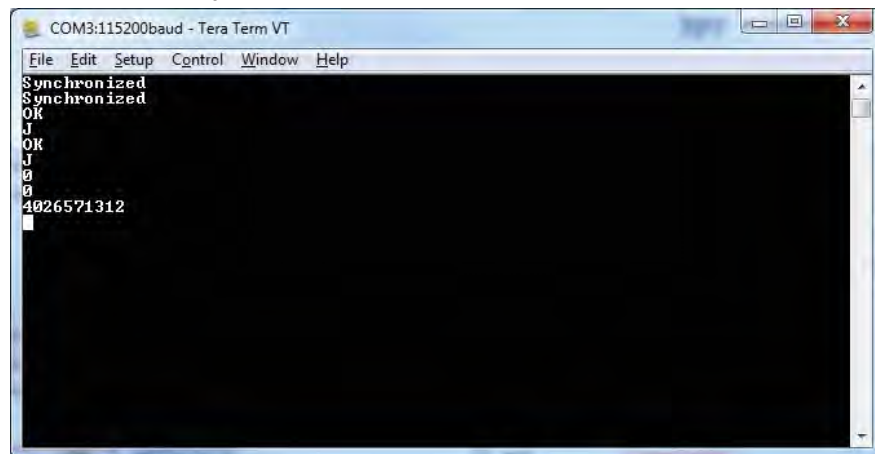
Incorrect example:

The 'J' command in ISP mode should return an error code, followed by an ASCII string representation of the part ID, followed by a 0. However what is actually returned is the error code, followed by a 0, followed by an ASCII string representation of the part ID. The problem is the last two items returned are swapped.

There is no work-around for this problem.

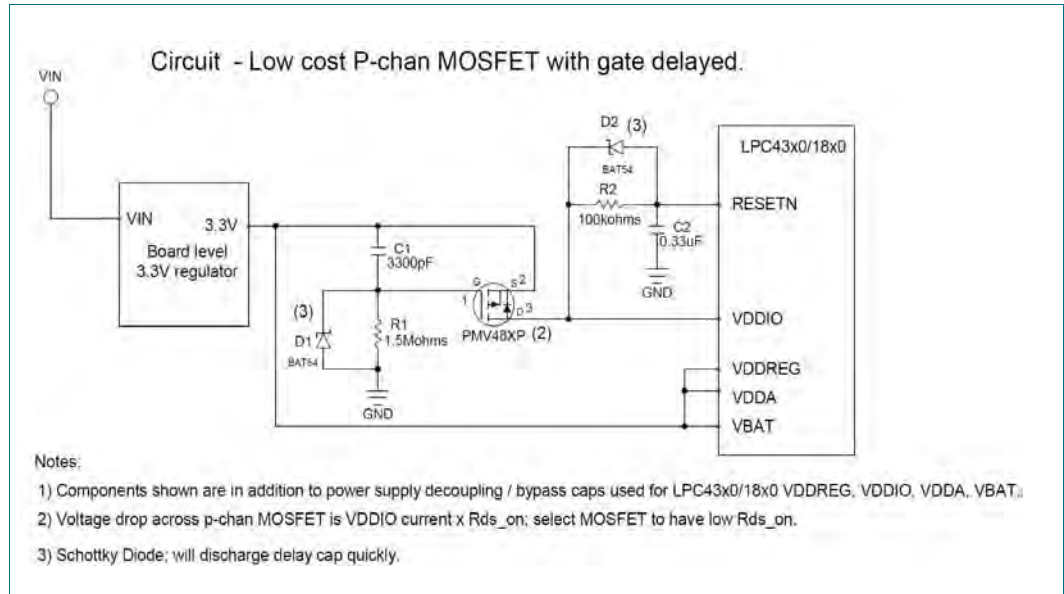
On all packages, repeated power cycling of the device may cause erroneous programming of the OTP banks. During ramp-up, the VDDREG supply voltage does not have enough time to settle and initialize the OTP controller before valid programming voltage is reached on the VPP pin. This may cause accidental programming of the OTP banks. Accidental programming of the OTP banks does not occur during Power-down of the supply voltage.

- Do not tie VDDIO to VDDREG and VDDA pins. The power supplied to the VDDIO pin should be delayed by 2 ms after the power supply on the VDDREG and VDDA pins stabilizes at the operating voltage level. The signal to the RESETN pin must also be delayed by 2 ms after the power supply on the VDDIO pin stabilizes at the operating voltage level.

The following circuit diagram is an example that shows the P-channel MOSFET with the gate delayed and the R-C delay circuit connected to the RESETN pin.

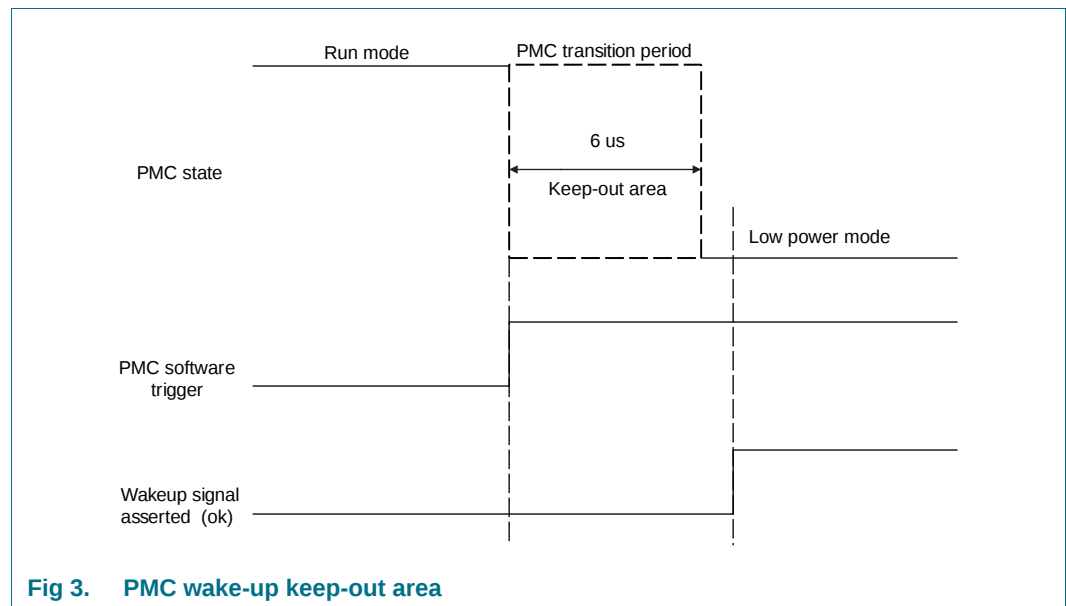
Fig 3. PMC wake-up keep-out area

When the chip is in a transition from active to Deep Sleep, Power Down, or Deep Power Down, wake-up events are not captured and they will block further wake-up events from propagating. The time window for this transition is 6  $\mu$ S and is not affected by the chip clock speed. After a wake-up event is received during the PMC transition, the chip can only recover by using an external hardware reset or by cycling power.

Make sure that a wake-up signal is not received during the Deep Sleep, Power Down, or Deep Power Down transition period. An example circuit to work around this could include an external 6  $\mu$ S one shot which could be triggered via software using a GPIO line when entering Deep Sleep, Power Down, or Deep Power Down mode. The one-shot's output could be used to gate the wake-up signal(s) to prevent receiving a wake-up signal during the PMC transition period. Depending on the system design, it may also be needed to latch the wake-up signal(s) so that they will still be present after the one-shot's 6  $\mu$ S time-out.

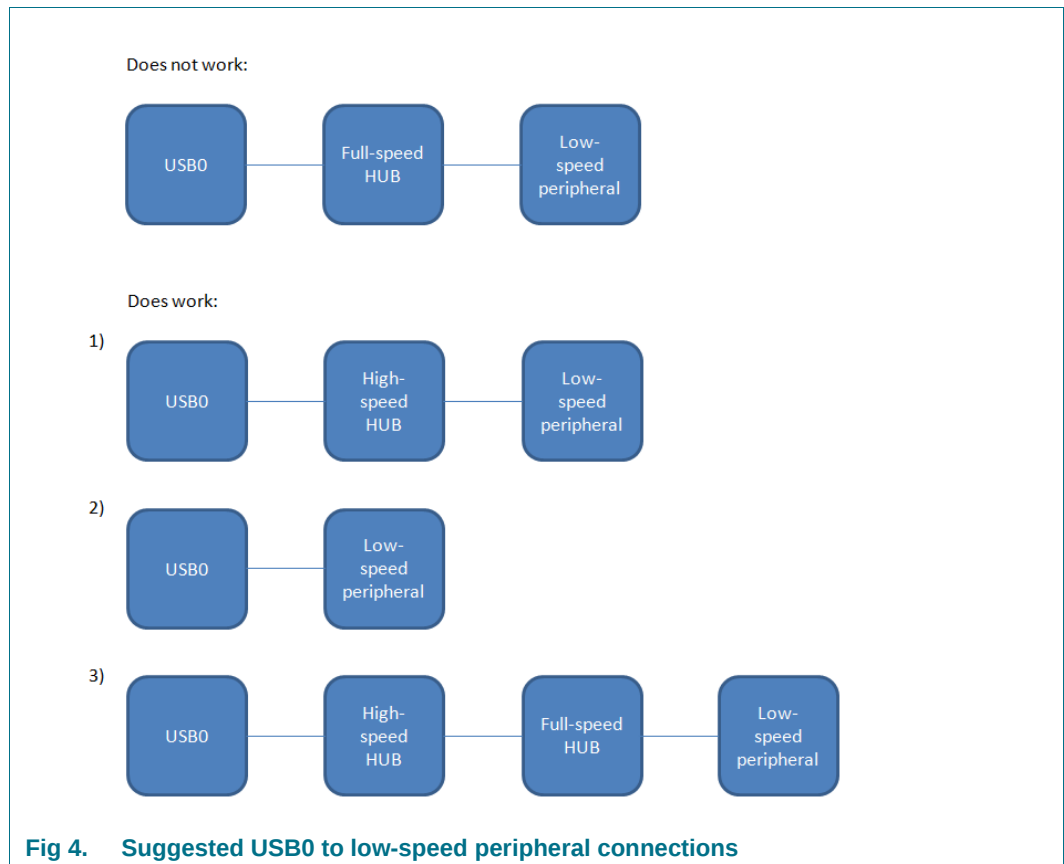
The USB controller called USB0 is unable to communicate with a low-speed USB peripheral in host mode when there is a full-speed hub directly connected to the USB0 port and a low-speed peripheral is connected in the tree somewhere below this full-speed hub. Only USB0 has this problem; the other USB controller, USB1 does not.

There is no work-around for this problem. It is suggested that the low-speed USB peripheral is either connected directly to USB0 or a high-speed hub is placed between that peripheral and USB0.
