# AMIS-3062x Evaluation Kit

## Test Procedure

Tom De Ryck  
June 23, 2009

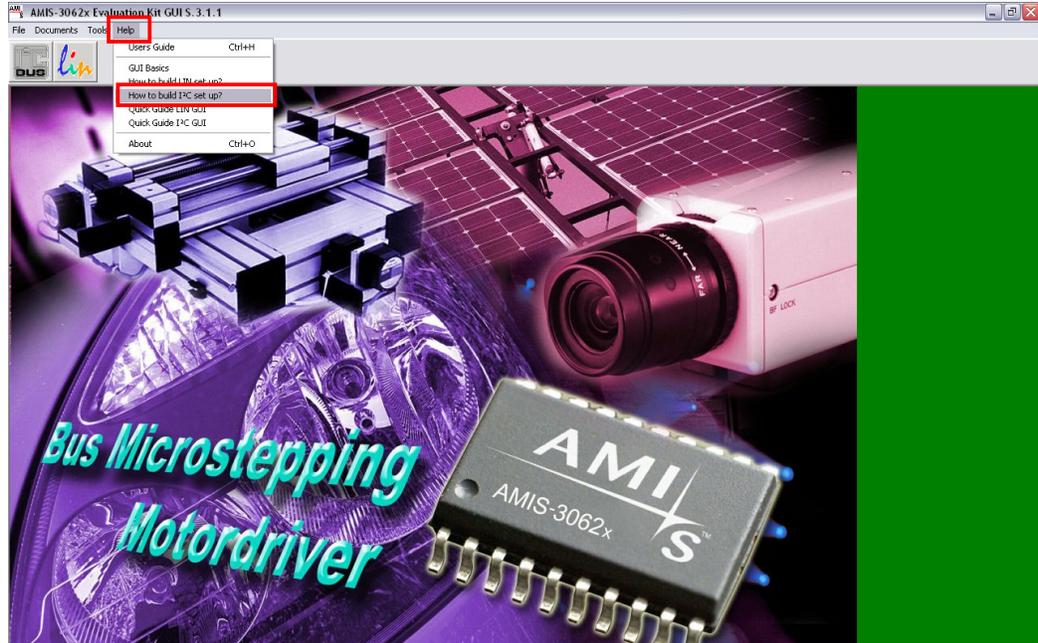
It's important to build the setup the first time by using a so-called Golden Reference Setup. A Golden Reference Setup is a setup with all known working parts<sup>2</sup>.

Figure 4: How to build the I<sup>2</sup>C setup

**Remark:** make sure all 4 jumpers on the Motherboard are placed in the GND position!

To build the I<sup>2</sup>C setup, go to “Help > How to build I<sup>2</sup>C set up?” to open a presentation on building the I<sup>2</sup>C setup. Follow all steps given in this presentation.

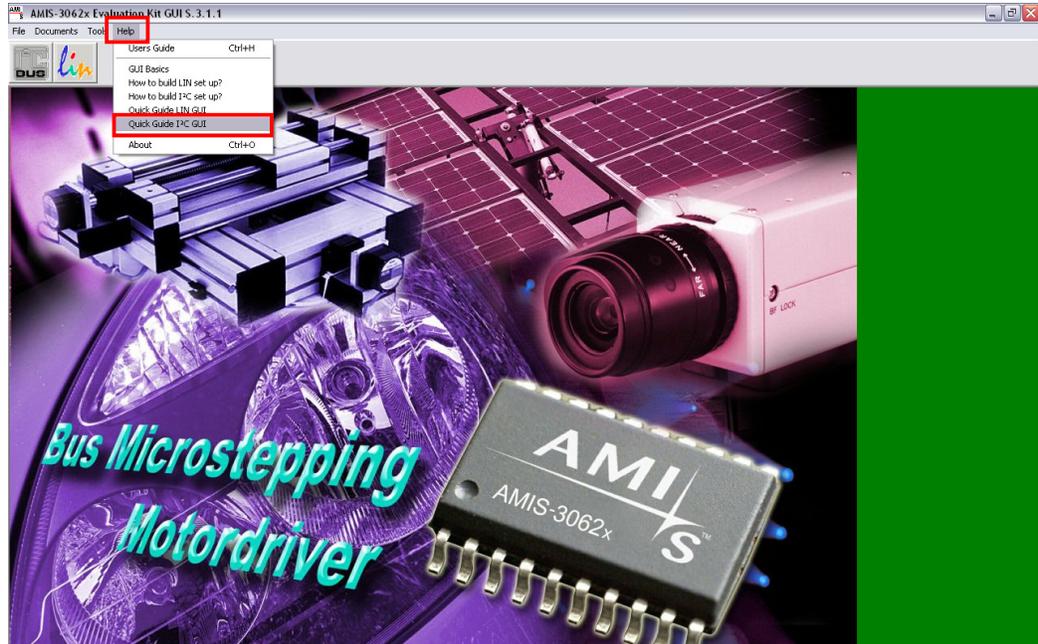
**Figure 5: Run the I<sup>2</sup>C test**

The stepper motor should have done the rotation. If not, check if the EcuSim MkII is connected properly with the PC running the AMIS-3062x Evaluation Kit GUI. Check if the Motherboard is powered and the I<sup>2</sup>C cable between EcuSim MkII and Motherboard is connected correctly. Check also if the Daughterboard is mounted correctly and the stepper motor is connected properly. If the problem can not be solved, restart the software and try again.

Go to “Help > Quick Guide I<sup>2</sup>C GUI” to open a presentation on testing the I<sup>2</sup>C setup. Follow all steps given in this presentation.
